### **Test Report**

Repoet No.: LT-201806-001

: LED LIGHTING FOR USE IN HAZARDOUS AND HARSH

LOCATION (MODEL L1102 – 100W)

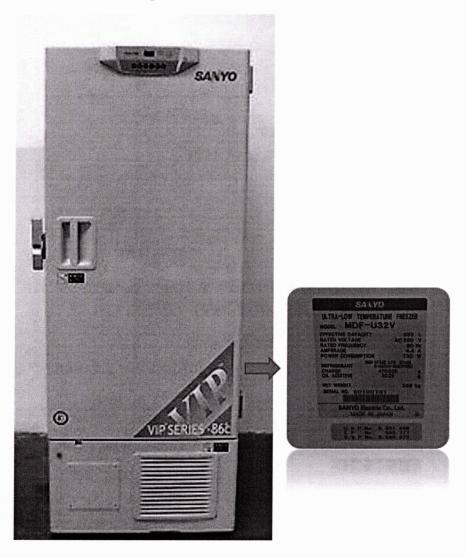
## Sanyo MDF-U32V Ultra-Low Temperature Freezer:

: Sanyo MDF-U32V Ultra-Low Temperature Freezer (as shown at page 3). **Test Equipment**

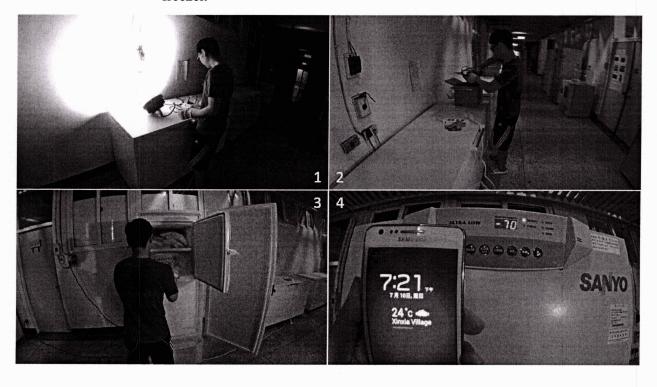
: LT-201806-001-1

: Place the LED Lighting into the freezer.

Testing procedure: 1. Power on the LED Lighting to make sure it is in normal operation.

Then, power off the LED Lighting.

2. Put the LED Lighting into the carton.

3. Place the carton with the LED Lighting into the freezer.

4. Record the date and time right after the LED Lighting is placed into the freezer.

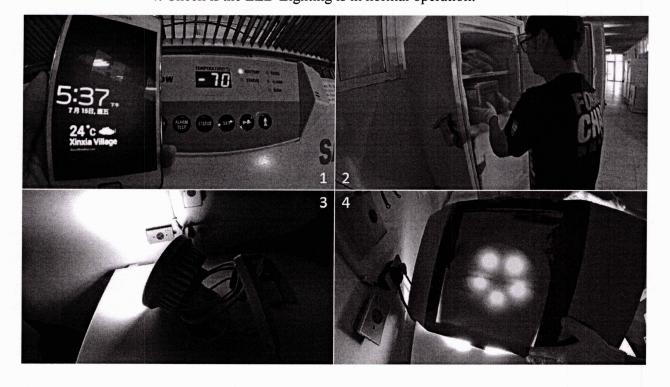
: LT-201806-001-1

: Take out the LED Lighting from the freezer.

Testing procedure: 1. Record the date and time right before the LED Lighting is taken out from the

freezer.

2. Take out the LED Lighting.

3. Power on the LED Lighting.

4. Check if the LED Lighting is in normal operation.

Test No.	Test Temperature	LED Lighting is powered off At Low Temperature			Power-on
		Start Time	End Time	Total Time	Test Results
LT-201806-001-1	-70°C	2016/07/10	2016/07/15	118 hrs 16 mins	Normal
		19:21	17:37		
LT-201806-001-2	-70°C	2016/07/15	2016/07/21	143 hrs 02 mins	Normal
		17:47	16:49

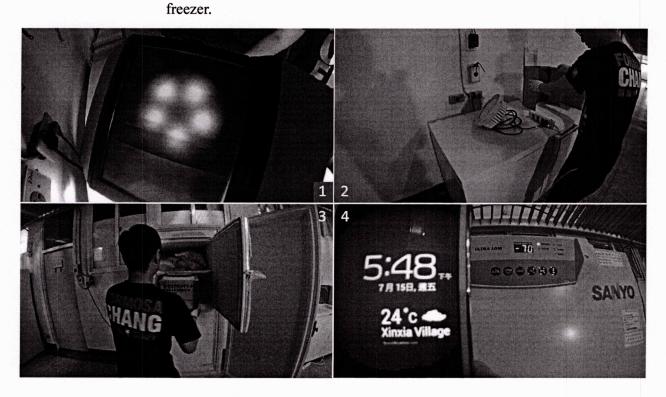
: LT-201806-001-2

: Place the LED Lighting into the freezer.

Testing procedure: 1. Power on the LED Lighting to make sure it is in normal operation.

Then, power off the LED Lighting.

2. Put the LED Lighting into the carton.

3. Place the carton with the LED Lighting into the freezer.

4. Record the date and time right after the LED Lighting is placed into the

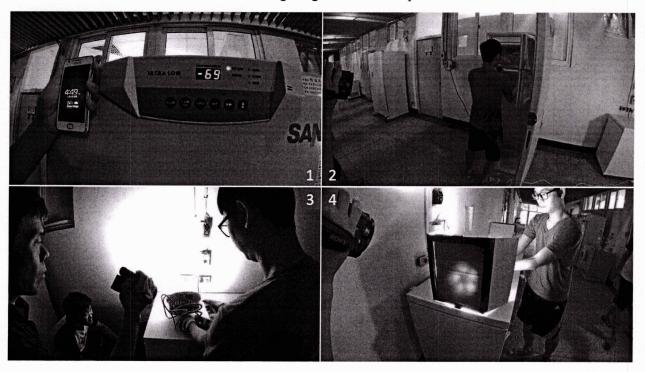
: LT-201806-001-2

: Take out the LED Lighting from the freezer.

Testing procedure: 1. Record the date and time right before the LED Lighting is taken out from the

freezer.

2. Take out the LED Lighting.

3. Power on the LED Lighting.

4. Check if the LED Lighting is in normal operation.

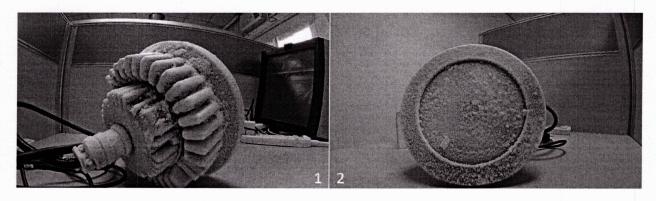
: LT-201806-001-2

: Record the physical appearance of the LED Lighting after it is taken out from

the freezer.
